**NORTHWEST RAPID TRANSIT
PROJECT INTEGRATED MANAGEMENT SYSTEM**

**CONSTRUCTION FLORA AND FAUNA
MANAGEMENT PLAN**

**SYDNEY METRO NORTHWEST
OPERATIONS, TRAINS and SYSTEMS PPP**

DOCUMENT NUMBER:	NWRLOTS-NRT-PRD-PM-PLN-000874
NRT-PIMS NUMBER:	PIMS-SP-17/02
REVISION:	08
CONTROL STATUS:	Unmaintained unless stated otherwise

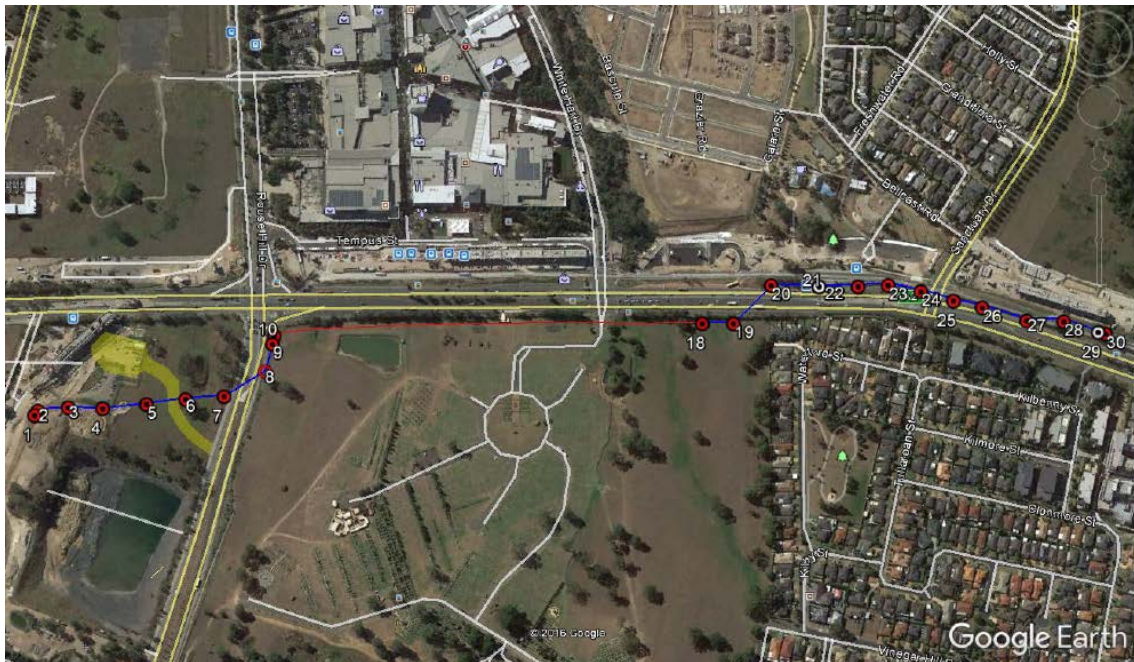
Figure 7 Rouse Temporary Bypass Powerline Work Area

The Rouse Temporary Bypass Powerline involves the construction of a temporary powerline from the southern side of the Sydney Metro Windsor Road Bridge crossing Schofields Road, running underground through Castlebrook Memorial Park transitioning back to overhead and crossing Windsor Road to the Rouse Hill traction substation located south of Sanctuary Drive. The purpose of the temporary powerline is to enable energisation and commissioning of the rail systems associated with the construction of Sydney Metro Northwest. See Figure 7 below.

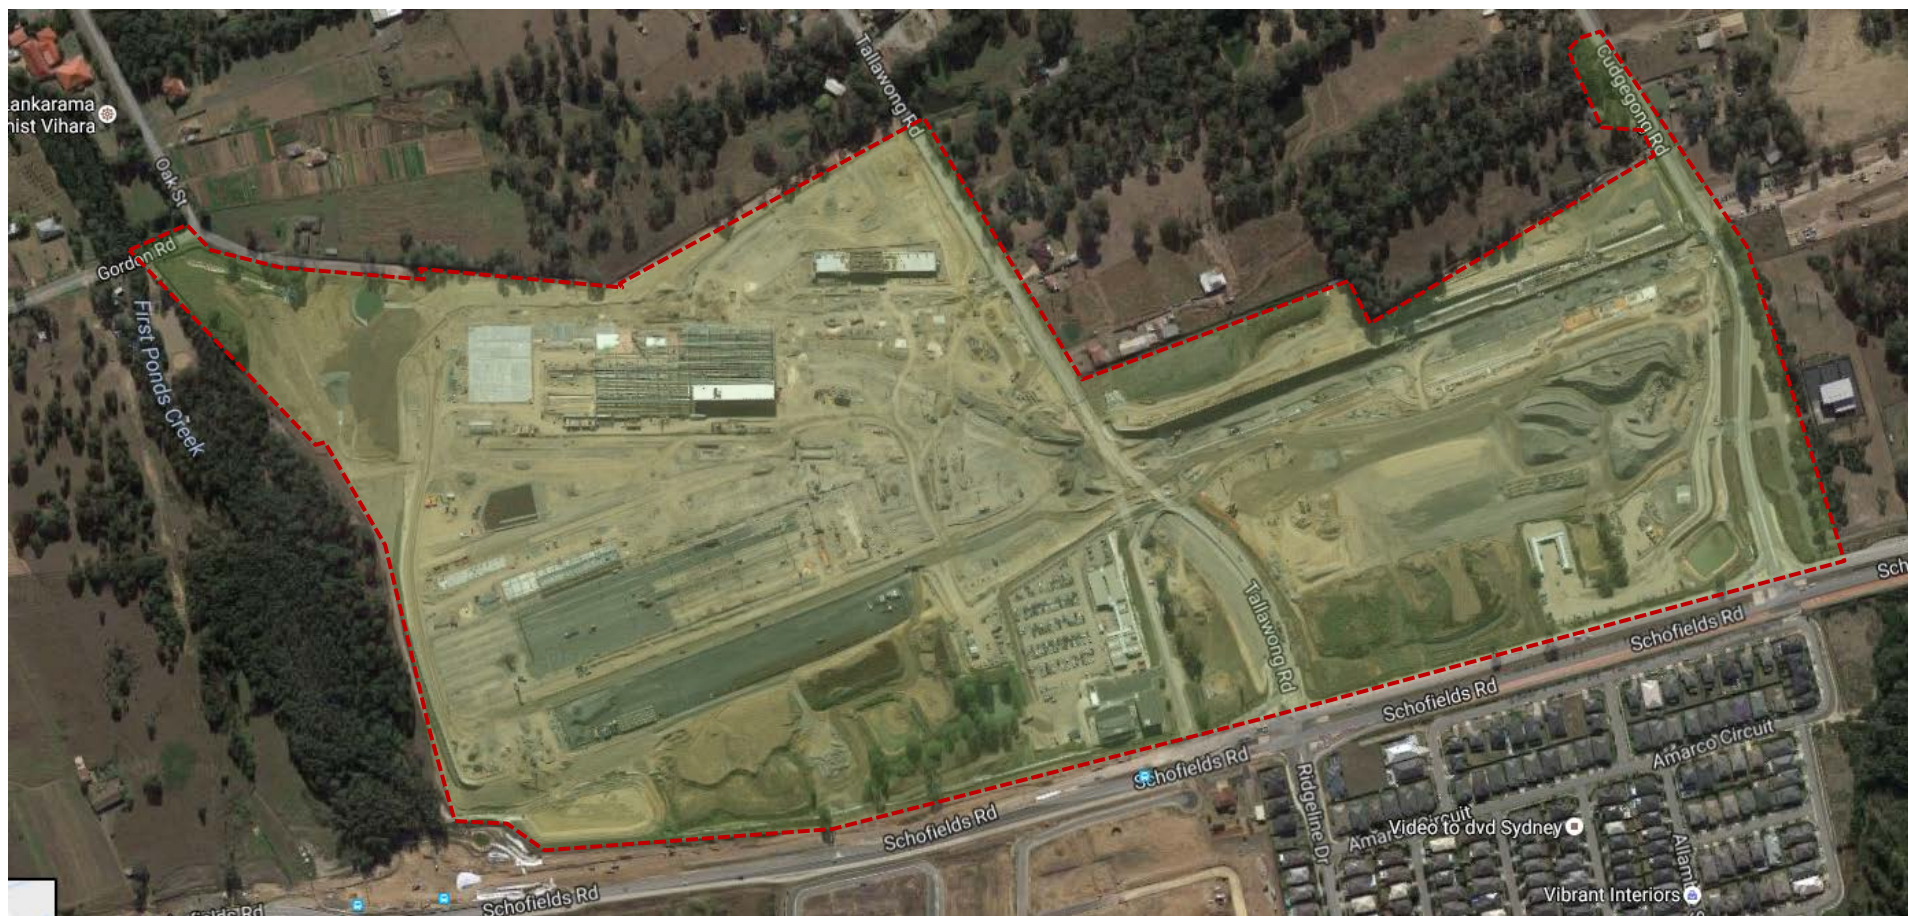
Figure D1 - SMTF and Cudgegong – Areas to be cleared shown within the red line

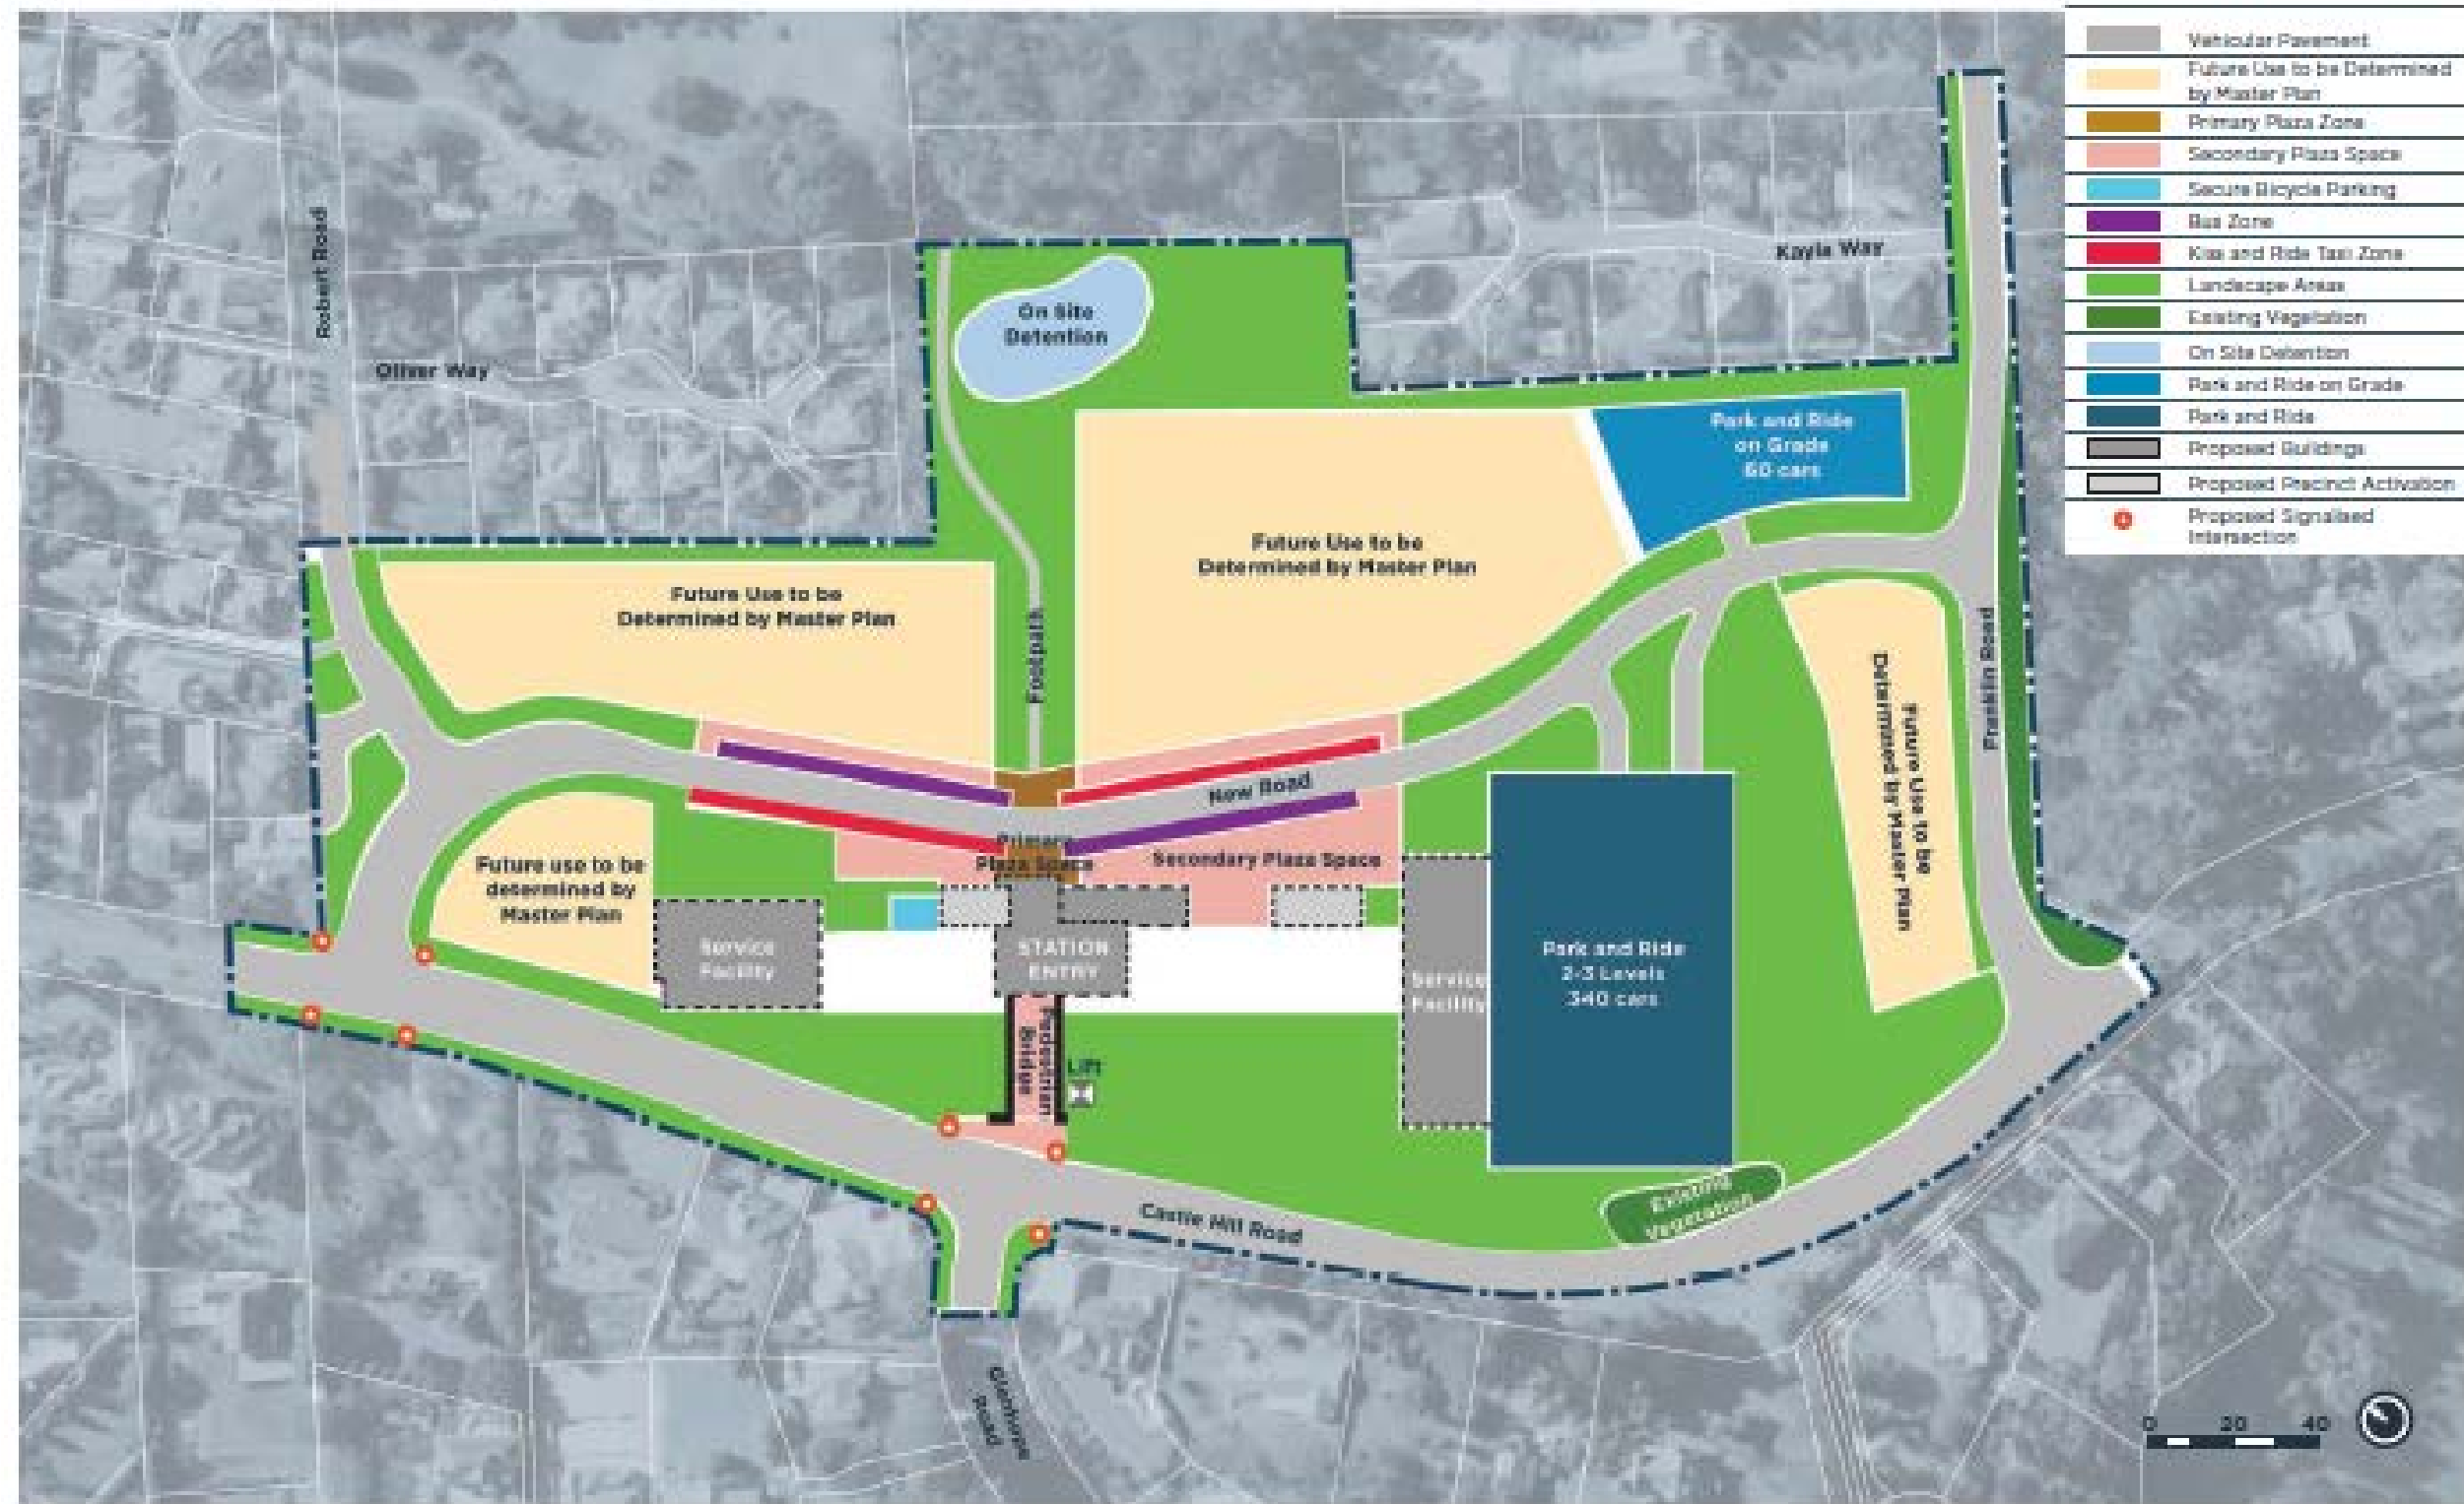
Figure D11 - Cherrybrook Worksite – Construction Boundary (i.e. clearing footprint) indicated dashed line.

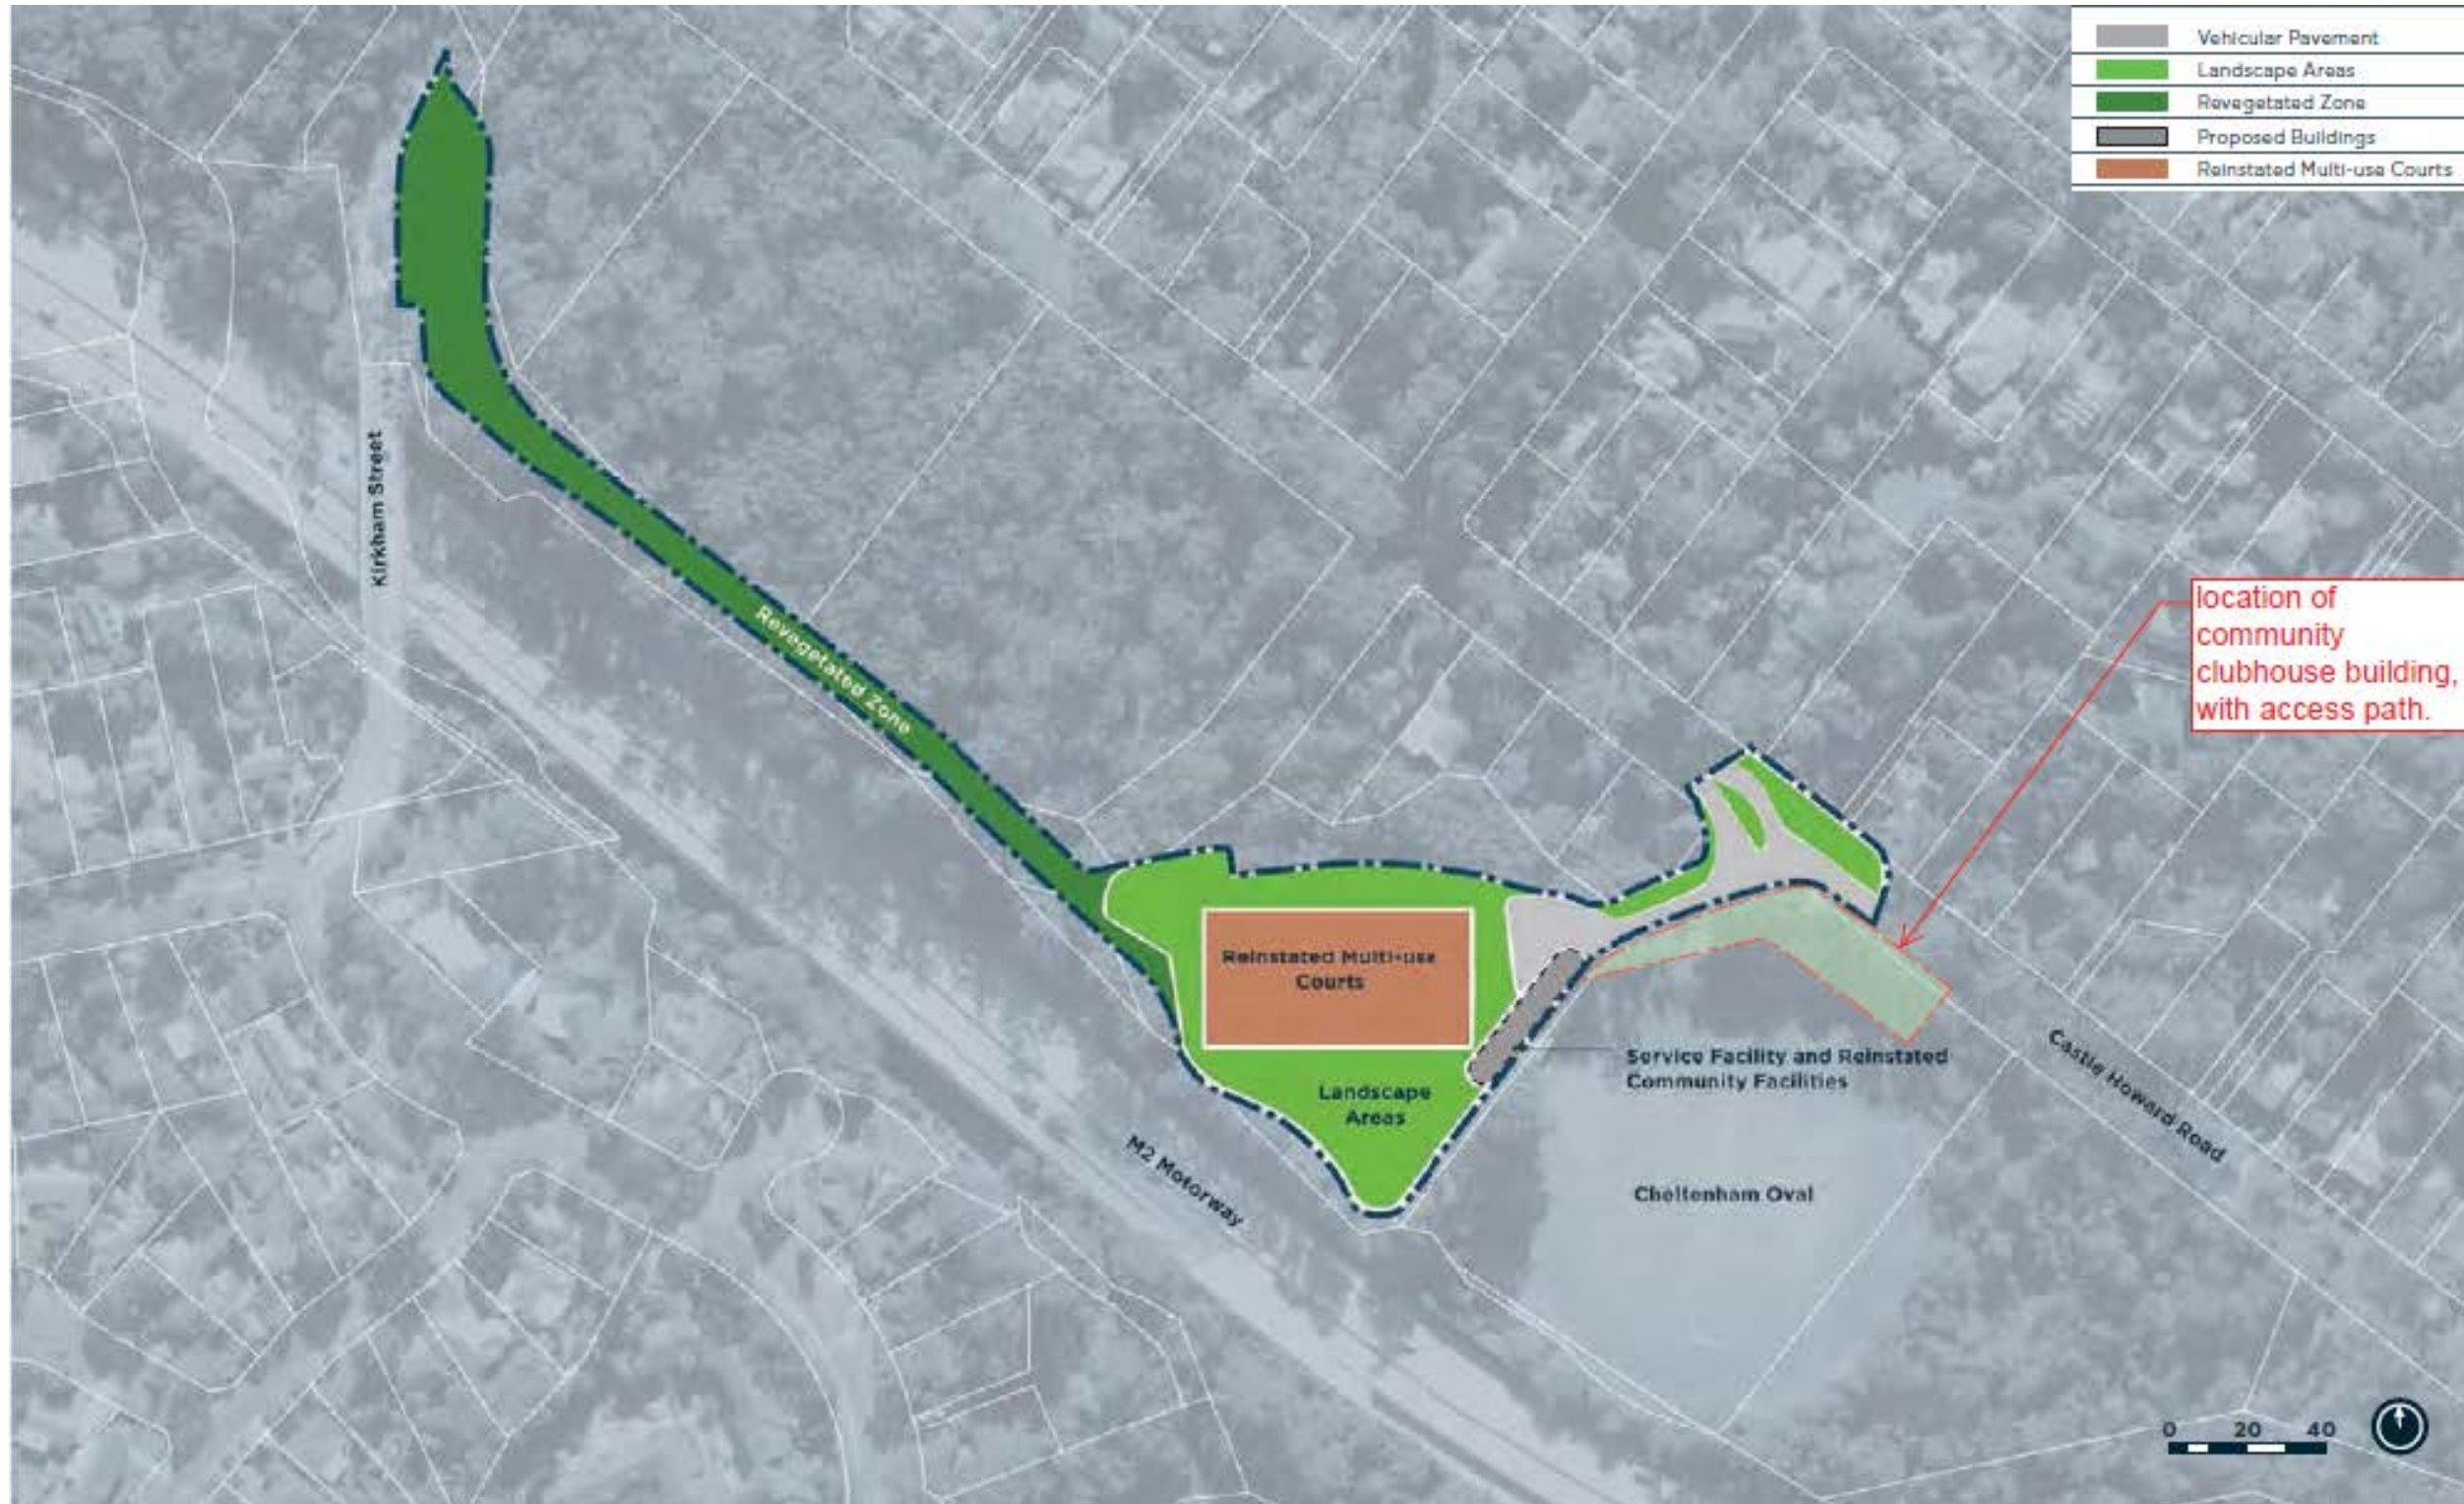
Figure D15 - Cheltenham Community Facility Worksite boundary

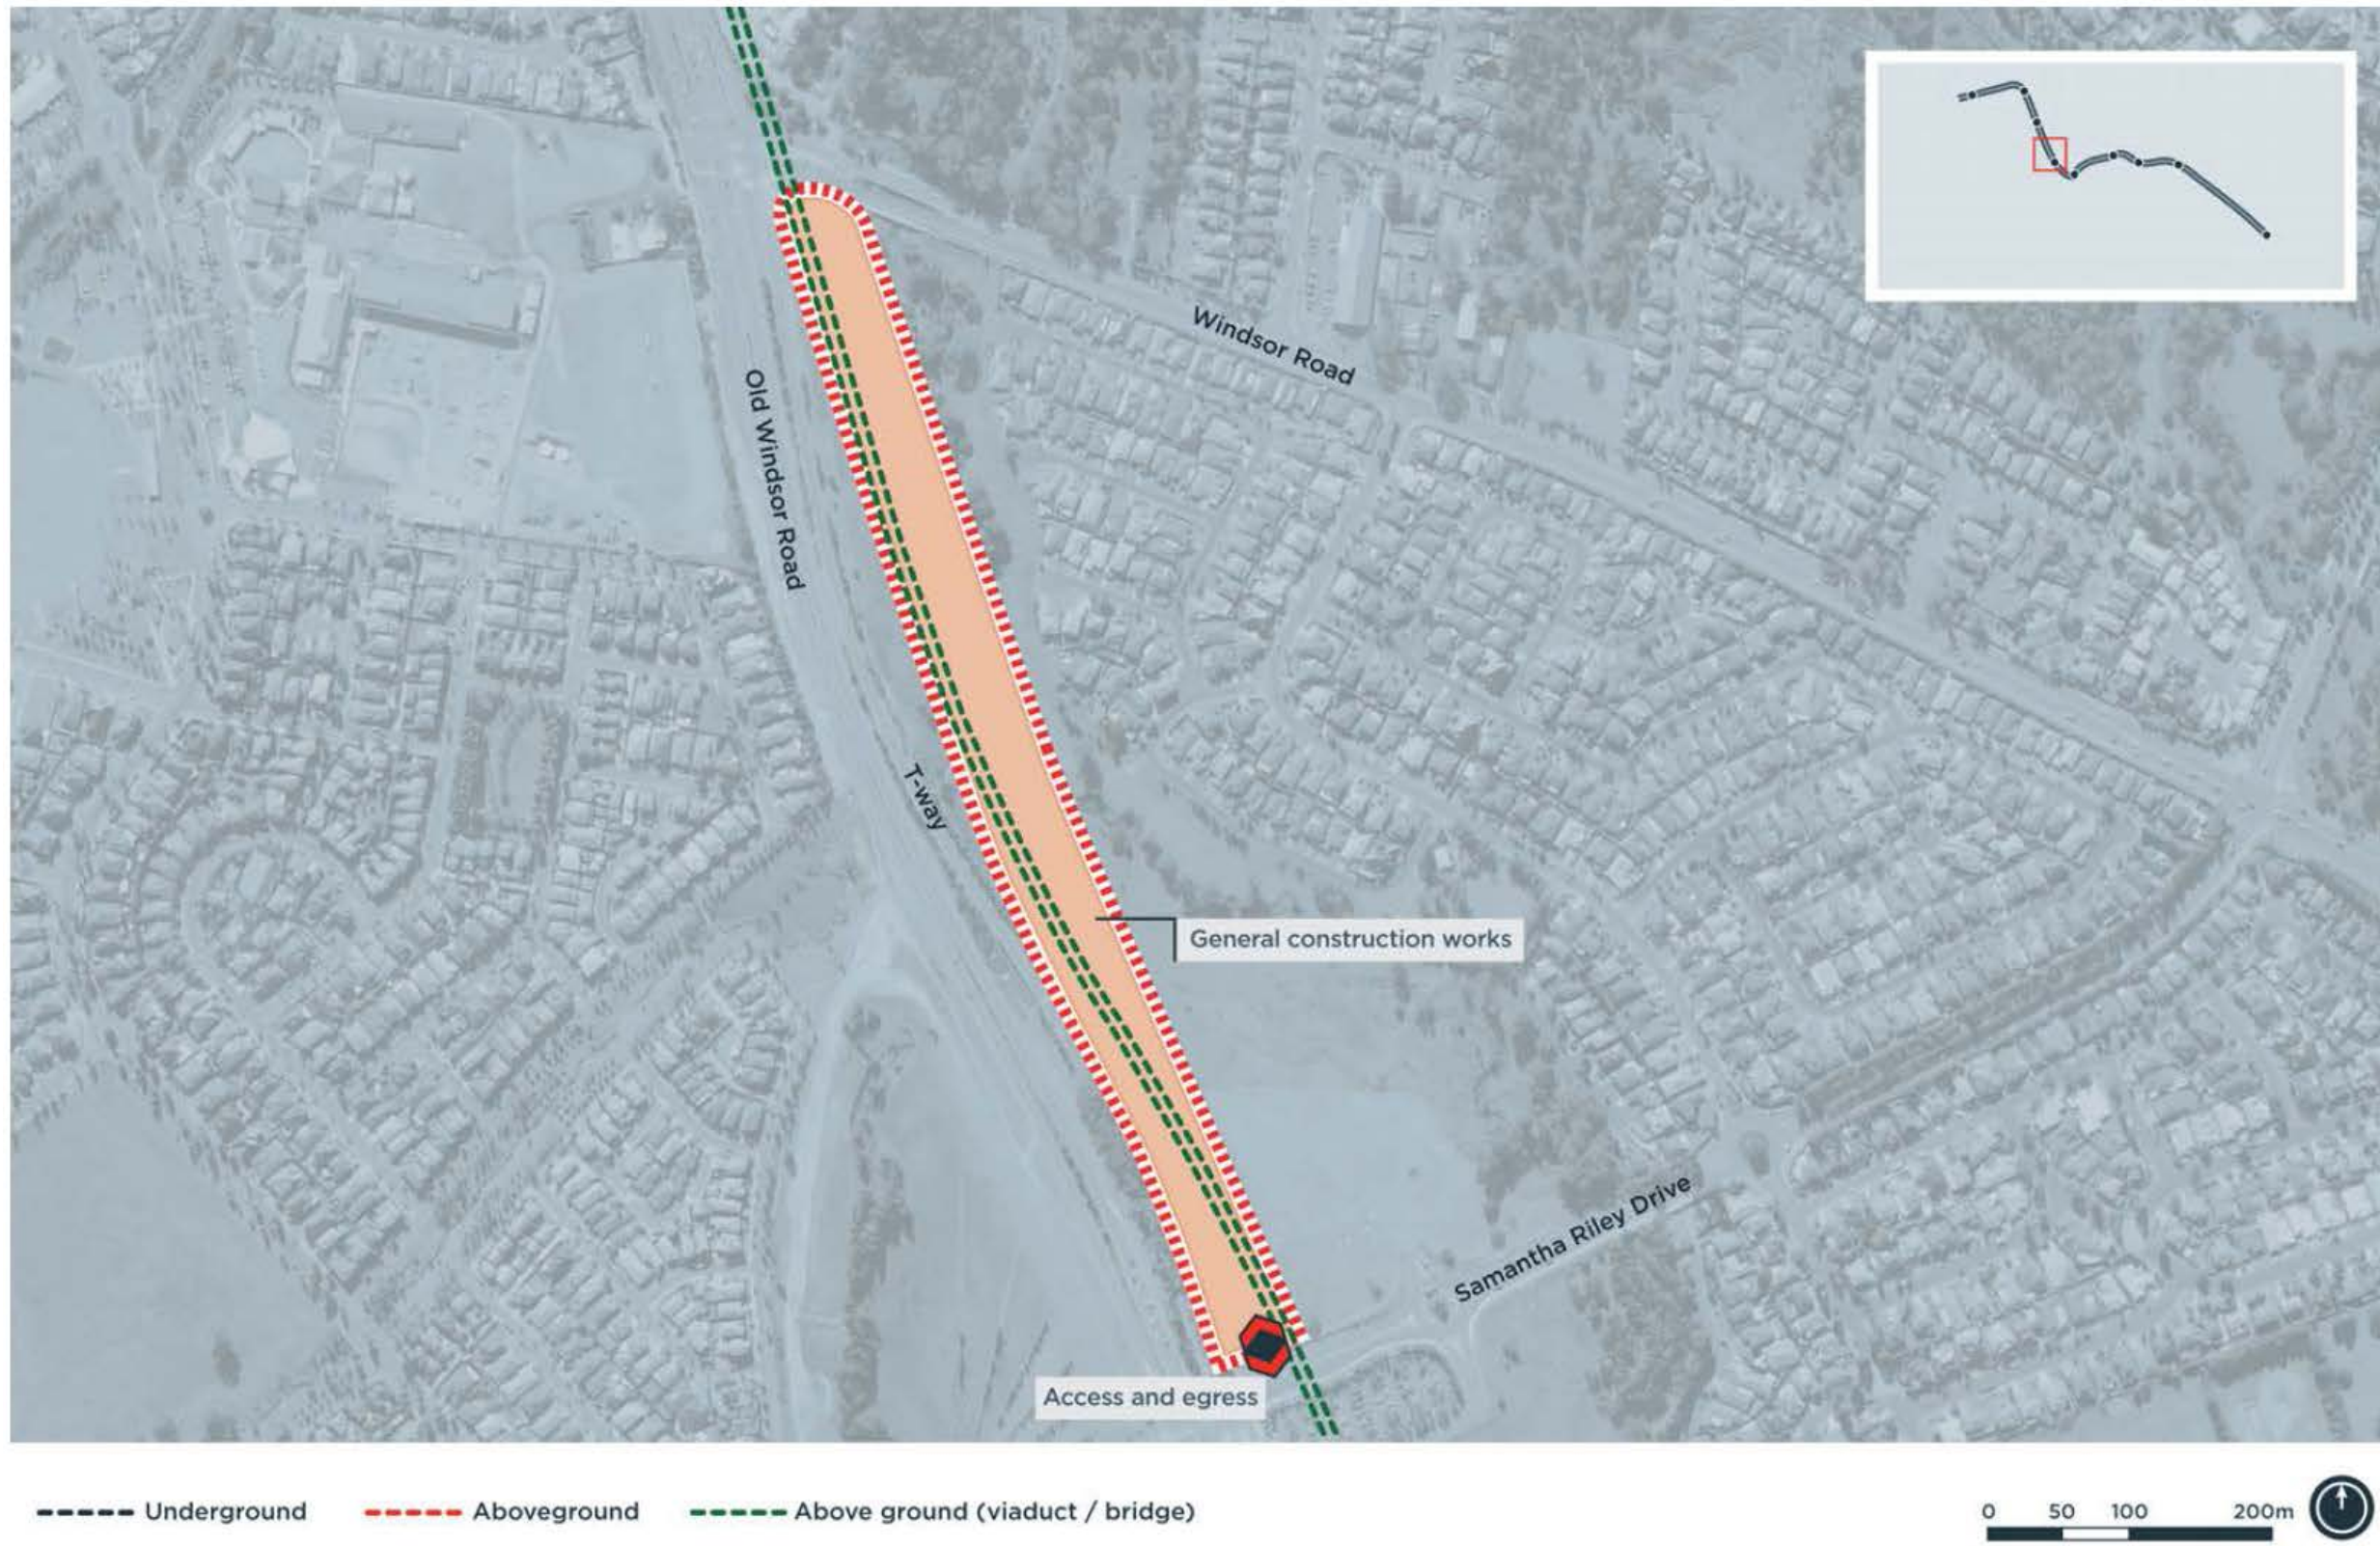
Figure D18 - Samantha Riley Drive to Windsor Road – Construction Boundary (i.e. clearing footprint) indicated in red dashed line.

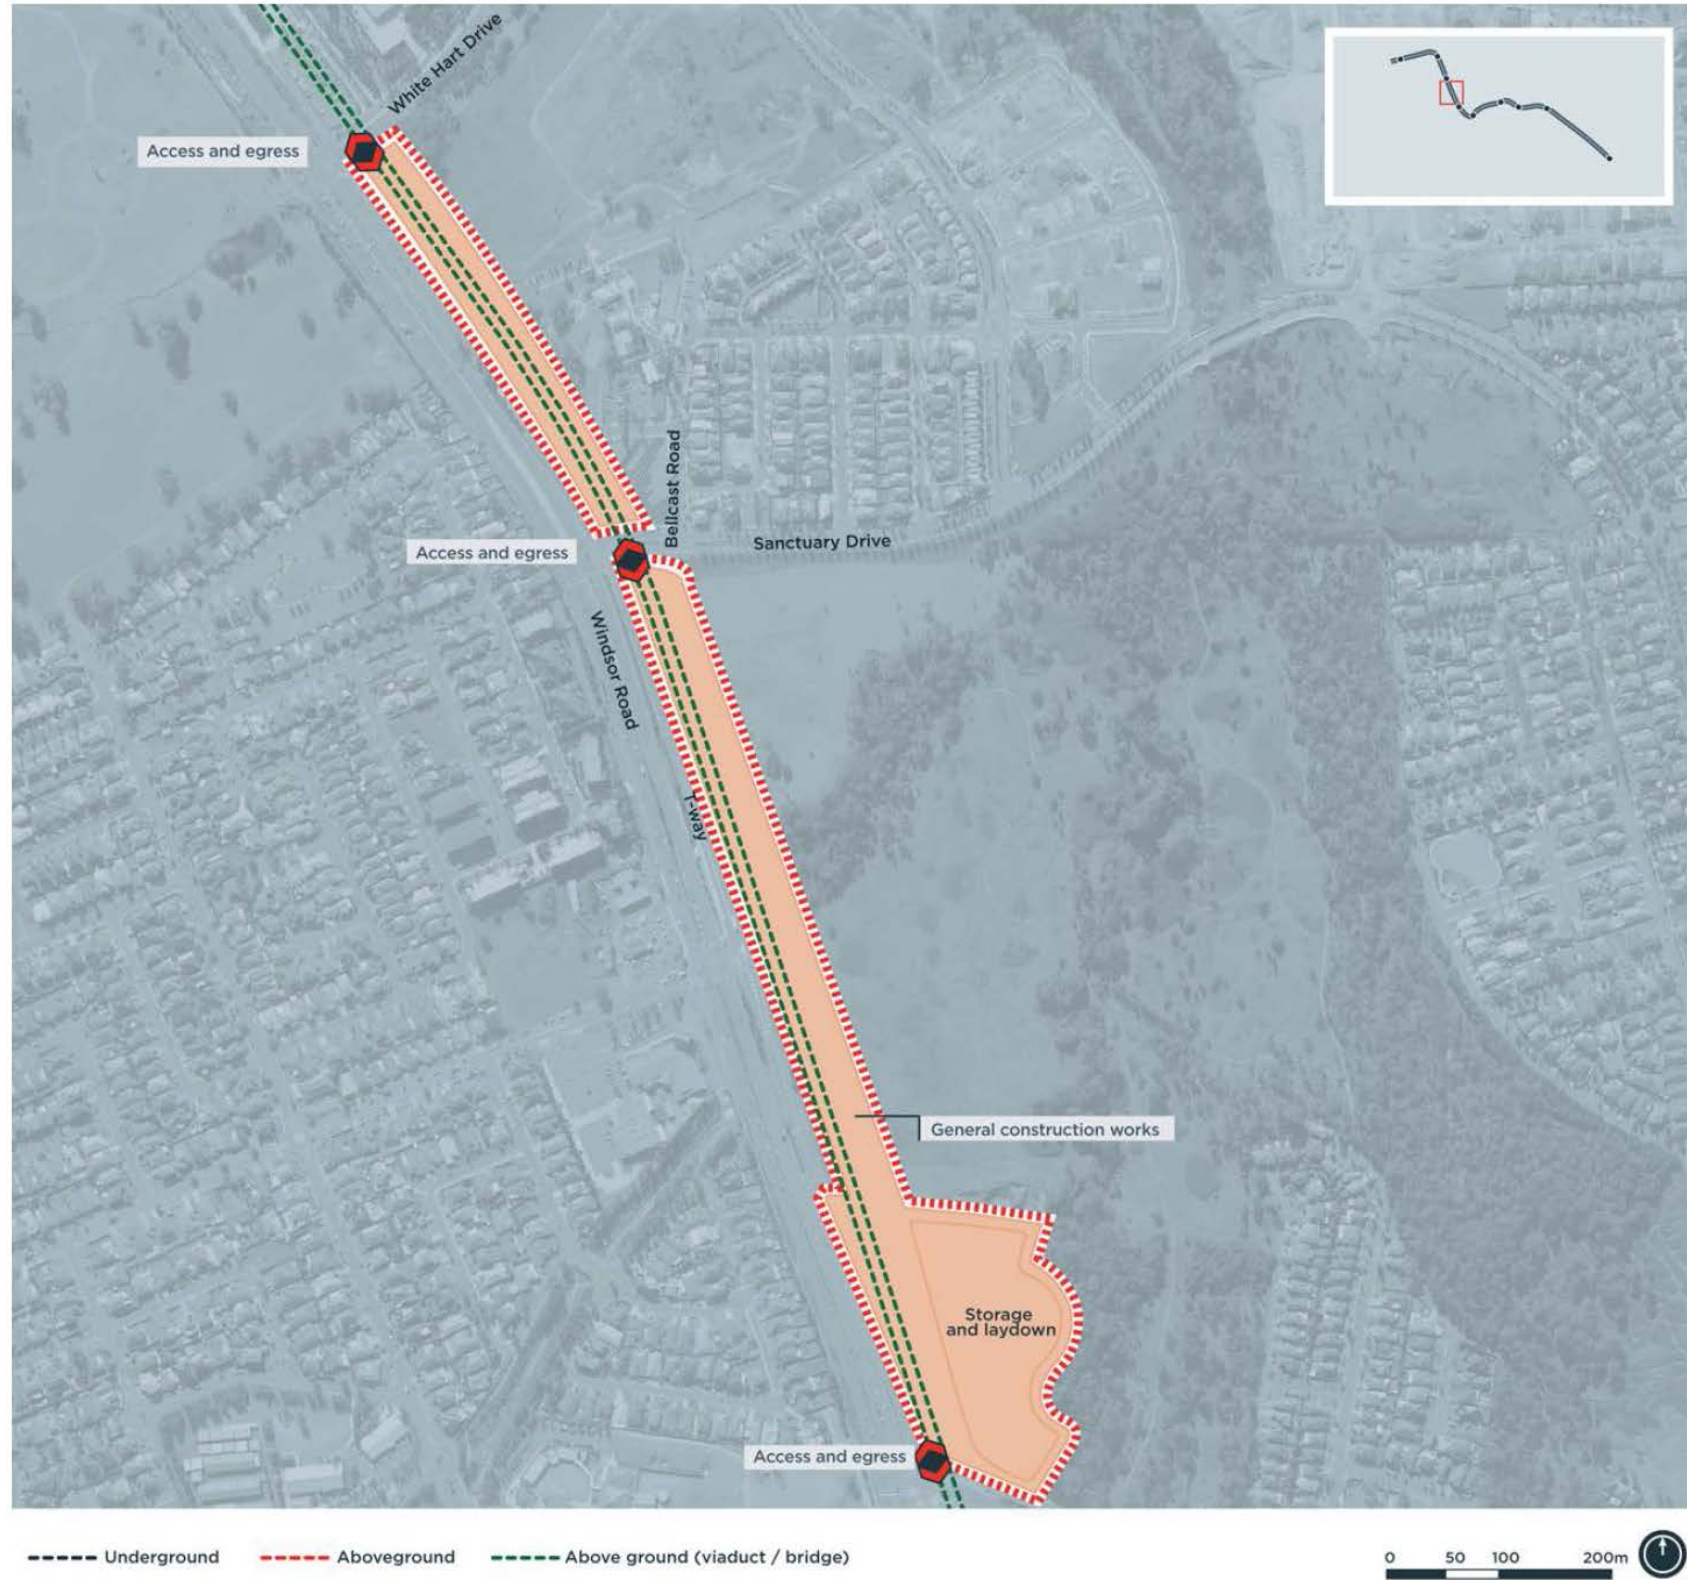
Figure D19 - Windsor Road to White Hart Drive – Construction Boundary (i.e. clearing footprint) indicated in red dashed line.

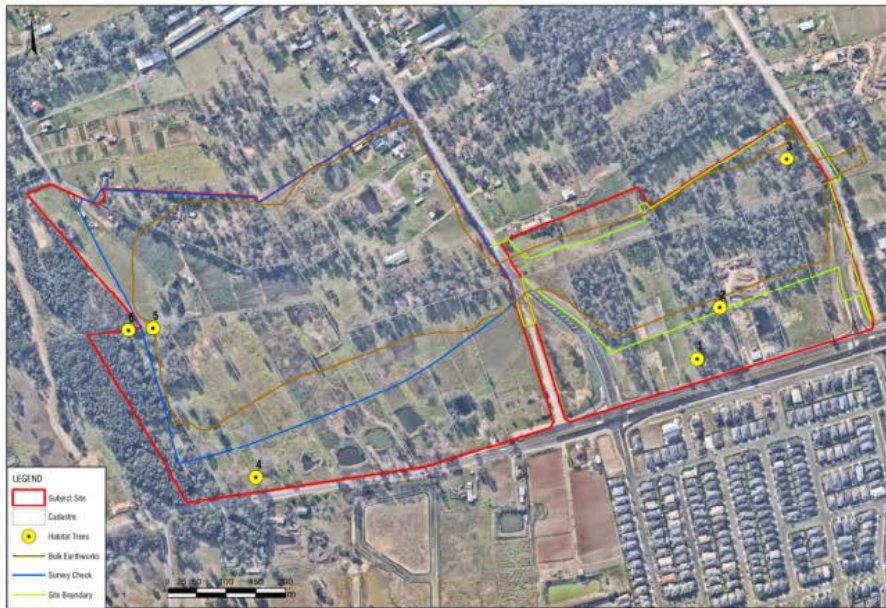
Figure 2 Habitat Trees

Six habitat trees which contained a few small to medium sized hollows were identified during the recent site inspection (see Figure 2 below). These trees may provide habitat to common birds, micro-bats and possibly the Brush-tail or Ringtail Possum. These trees will be subject to slow-drop removal procedure in accordance with the development conditions (including slow-drop felling with an ecologist or suitably qualified wildlife handler present).

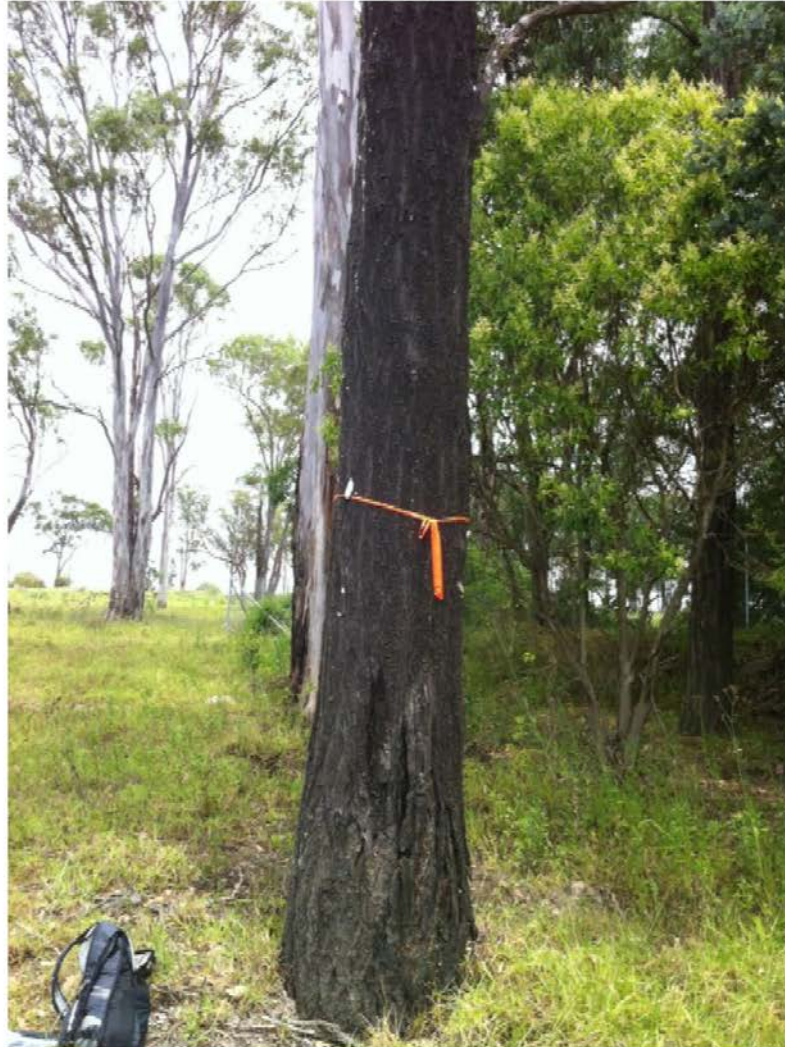
Photo 1 Habitat Trees have been mapped and tagged across the site.

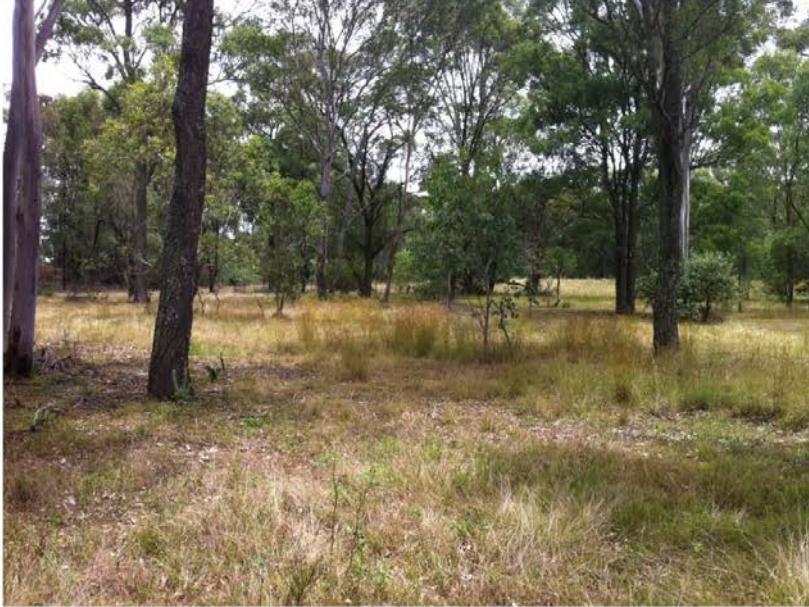
Photo 2 Areas of moderate condition woodland in the southeast of the site

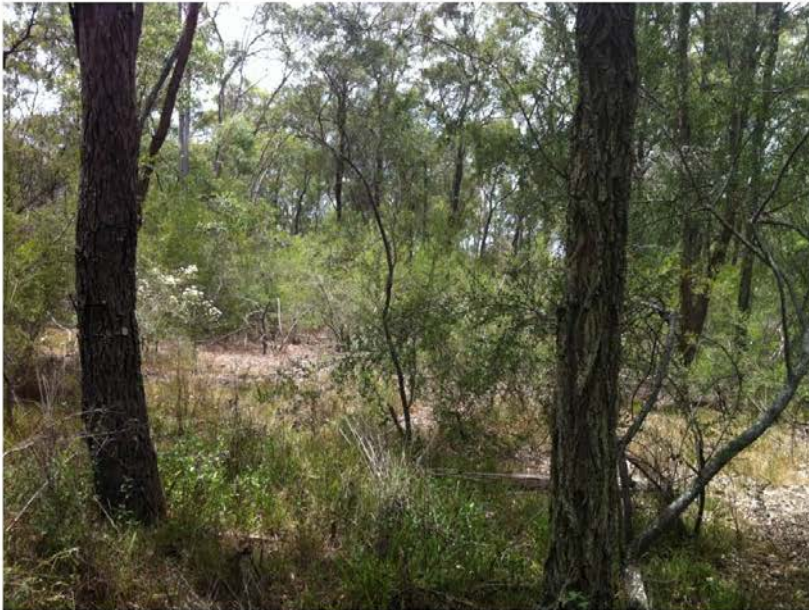
Photo 3 Areas of moderate condition woodland in the southeast of the site

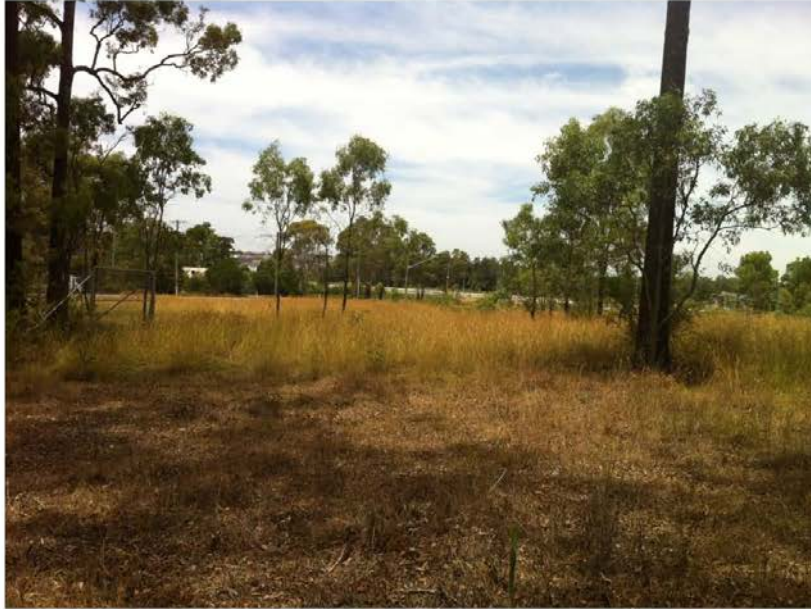
Photo 4 Areas of moderate condition *Themeda australis* grassland in the southeast of the site

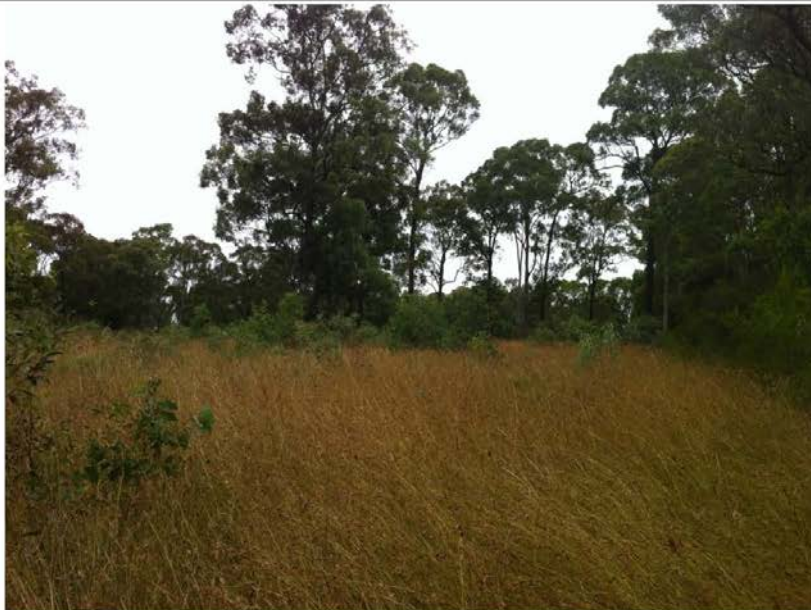
Photo 5 Areas of moderate condition *Themeda australis* grassland in the southeast of the site
