**NORTHWEST RAPID TRANSIT  
PROJECT INTEGRATED MANAGEMENT SYSTEM**

**CONSTRUCTION HERITAGE  
MANAGEMENT PLAN**

**SYDNEY METRO NORTHWEST  
OPERATIONS, TRAINS and SYSTEMS PPP**

DOCUMENT NUMBER:	NWRLOTS-NRT-PRD-PM-PLN-000878
NRT-PIMS NUMBER:	PIMS-SP-17/10
REVISION:	06
CONTROL STATUS:	Unmaintained unless stated otherwise

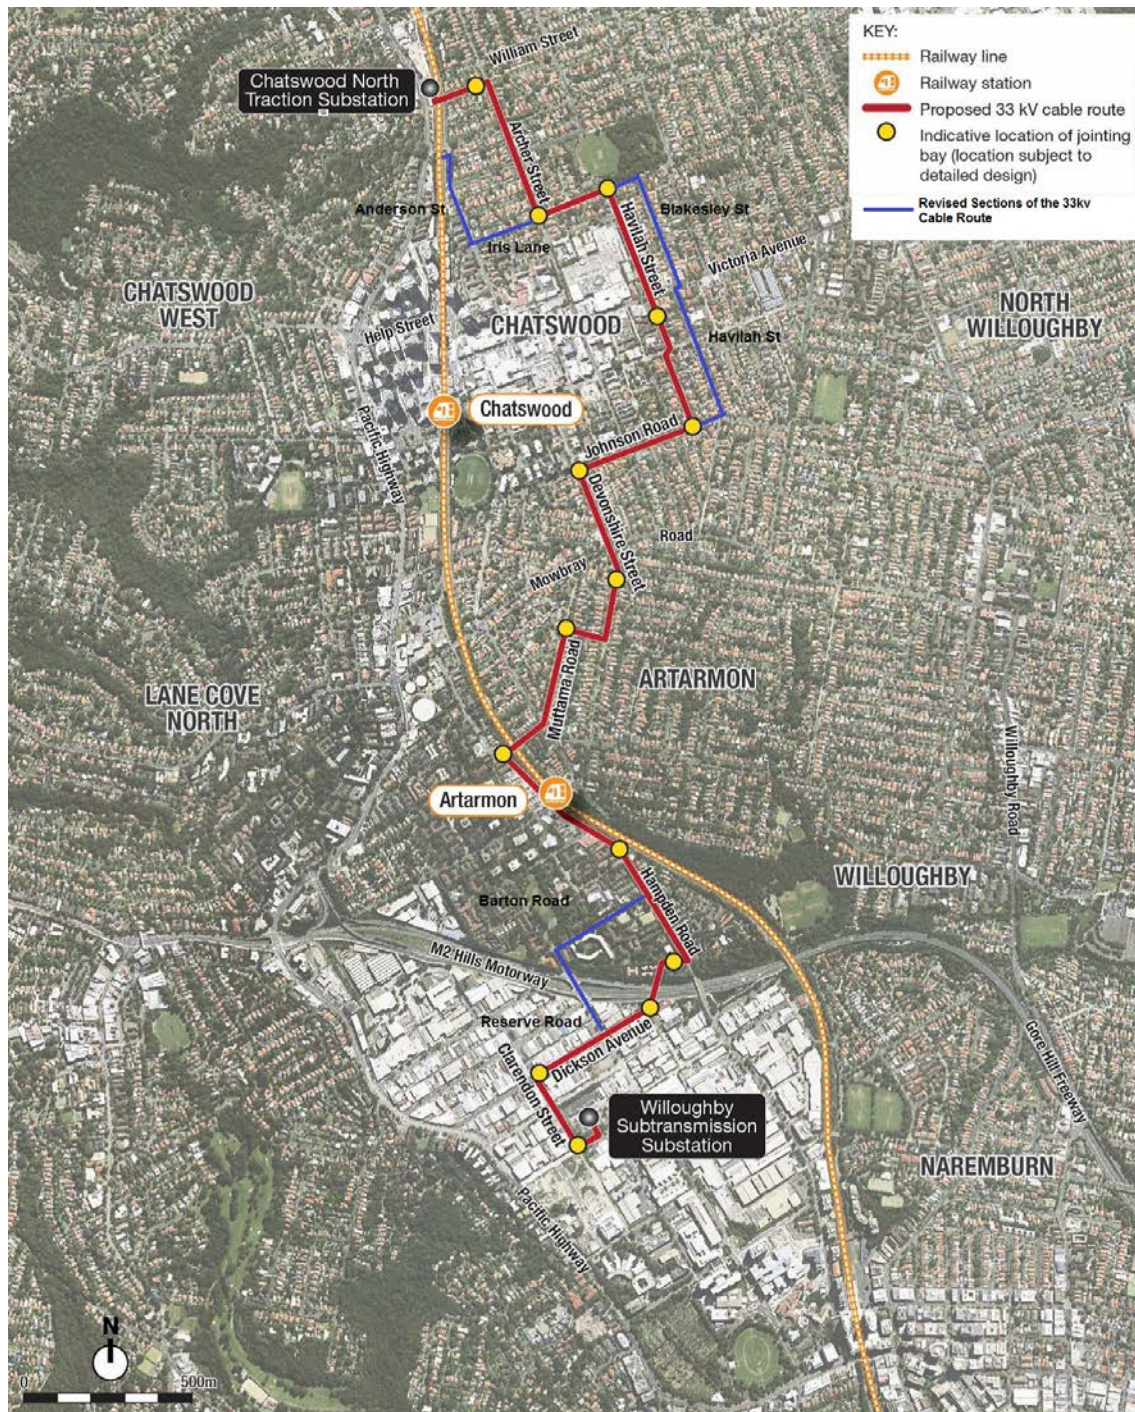
Figure 6 Overview of the 33kV Underground Feeder Powerline Route

Subtransmission Substation and the TfNSW Chatswood North Traction Substation. The proposal is required to provide dedicated, independent 33kV connection in order to meet the reliable supply of electricity requirements for this project. See Figure 6.

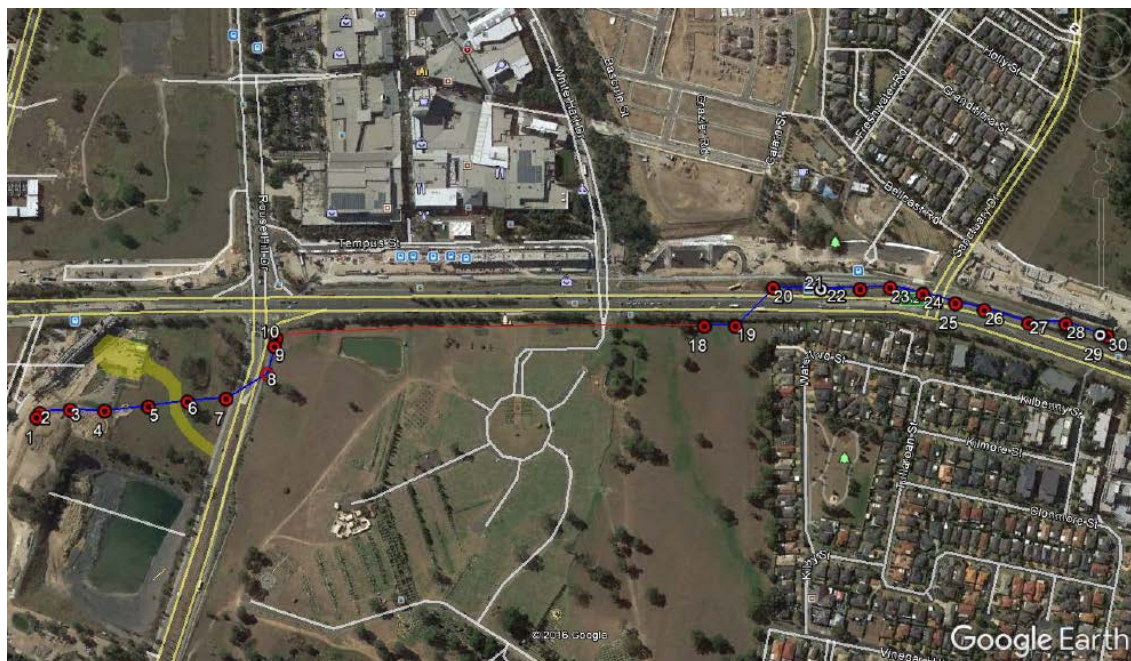
*Figure 7 - Rouse Hill Temporary Bypass Powerline Work Area*

The Rouse Temporary Bypass Powerline involves the construction of a temporary powerline from the southern side of the Sydney Metro Windsor Road Bridge crossing Schofields Road, running underground through Castlebrook Memorial Park transitioning back to overhead and crossing Windsor Road to the Rouse Hill traction substation located south of Sanctuary Drive. The purpose of the temporary powerline is

to enable energisation and commissioning of the rail systems associated with the construction of Sydney Metro Northwest. See Figure 7 below.

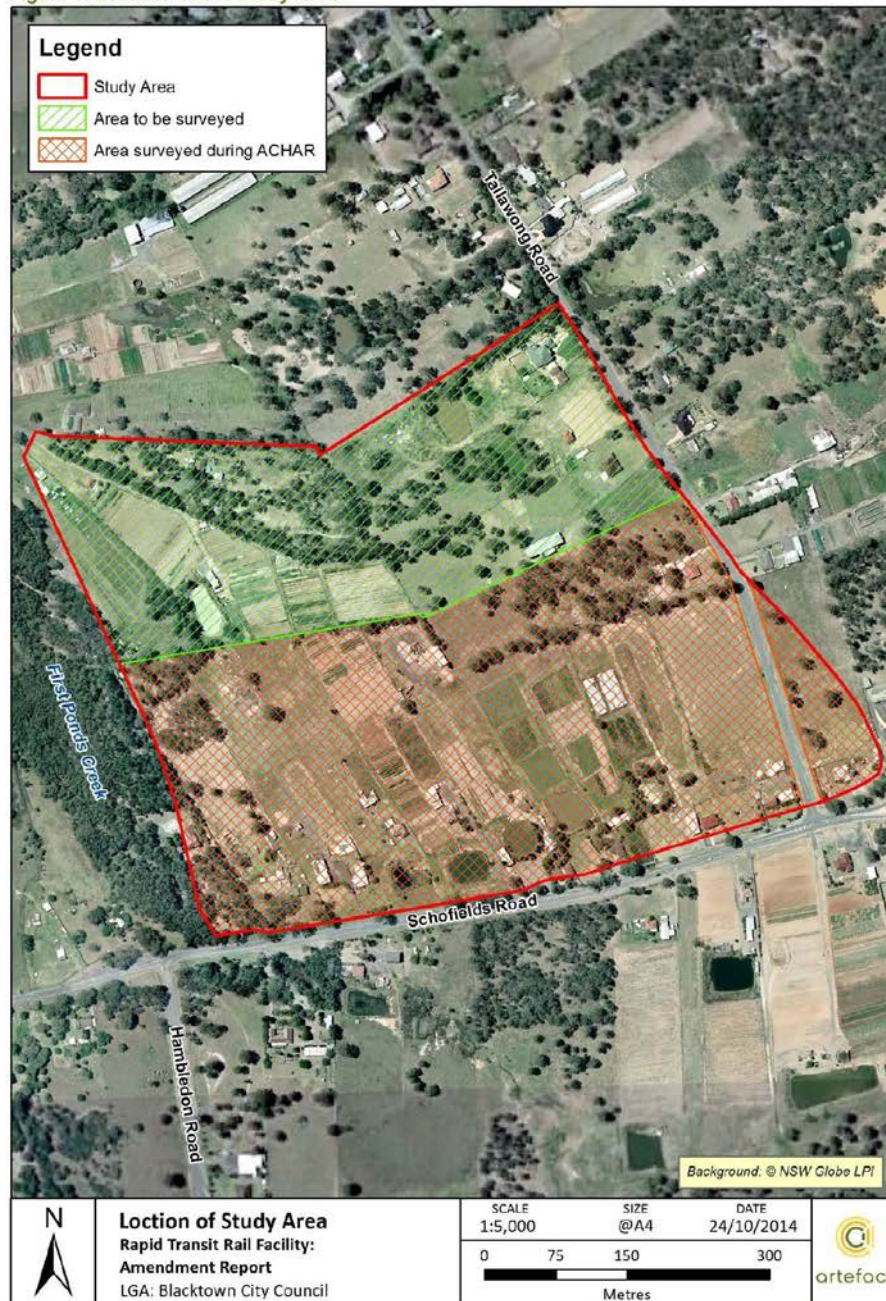
Figure 1: Location of the Study Area

This addendum report will detail the results of the addition survey of the northern half of the study area; which were unable to be surveyed during the course of the ACHAR investigations (Figure 1). This area comprises 47, 51 and 57 Tallawong Road; 2 and 5 Oak Street, as well as a portion of 68 Gordon Road.

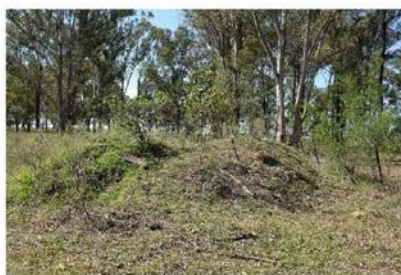
**Figure 6: Introduced materials at rear of 57 Tallawong Road. South aspect.**

The street frontage portions of 47, 51 and 57 Tallawong Road, all contained houses with associated sheds, dams and vehicle access roads (Figure 3 to Figure 5). These portions of the properties are highly disturbed. Large-scale landform modification and introduced materials were observed across those portions of each property. Large amounts of introduced materials formed into spoil piles were observed in the rear of 51 and 57 Tallawong Road (Figure 6). While 47 Tallawong Road has undergone substantial modifications during the construction of a large shed in the central portion of the property (Figure 7); undulations evident in the grassed area at the rear indicate past ground disturbance.

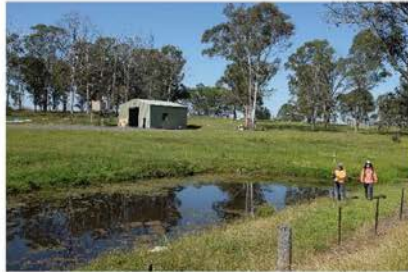
**Figure 7: Dam and shed located in 47 Tallawong Road. Southwest aspect.**

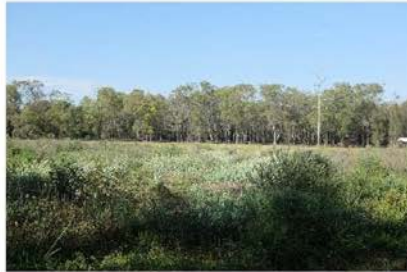
**Figure 8: Overgrown market garden area. West aspect.**

The properties in the southwest corner of the survey unit, 5 Oak Street and 68 Gordon Road, were former market gardens. Plough and furrow undulations were observed across these properties. However the ploughed areas have become overgrown, which hindered both access and visibility (Figure 8). A large dam is located within the south of 5 Oak Street, which has severely impacted the area (Figure 9).

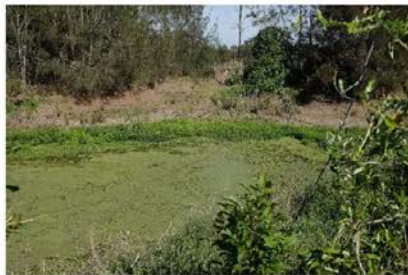
**Figure 9: Dam within 5 Oak Street. West aspect.**

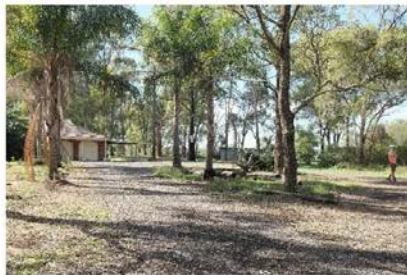
**Figure 10: Circular driveway at 2 Oak Street. East aspect.**

The street frontage of 2 Oak Street has been impacted by the construction of access tracks which run to the dwelling in centre of the property (Figure 10 and Figure 11). Around these dwelling are sheds, landscaped gardens and spoil piles of introduced materials. However the amount of native trees present within the property show that this is the least impacted area within survey unit 3 (Figure 12).

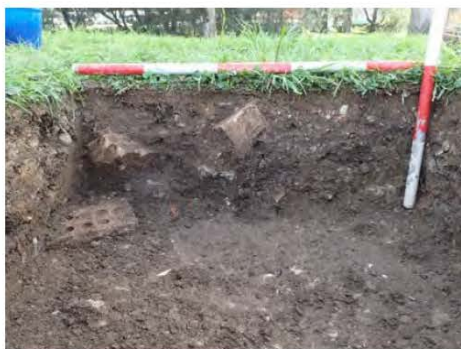
Plate 1. TS6, east facing section

0-5cm: Mid grey brown silty loam, humic, friable. Frequent fine root systems. Diffuse boundary to:

5cm-base: Disturbed deposit. Mid grey brown silty loam mixed with light grey and orange clay. Compact. Inclusions of brick, plastic, concrete rubble and blue metal.

Plates 1 and 2 illustrate typical soil profiles from test squares displaying this mixture of redeposited soils and fill.

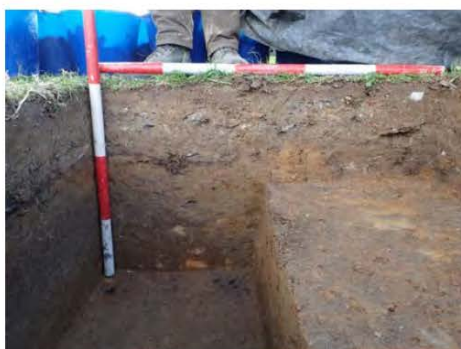
Plate 2. TS29, east-facing section with cut fill left to show contrast

0-5cm: Light grey brown silty loam, humic, friable. Frequent fine root systems. Diffuse boundary to:

25/50-55cm: Dark yellow brown silty loam. Infrequent fine root systems. Oxidised ironstone gravels <1cm 20%. Diffuse boundary to:

55cm-Base: Orange brown clay.

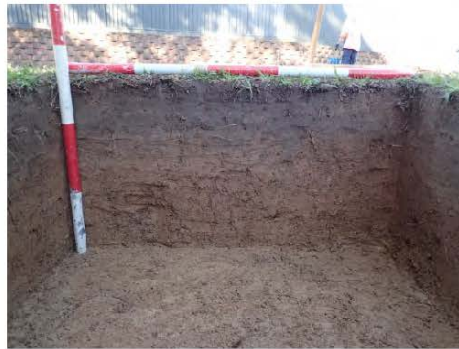
Plate 3. TS14, west-facing section

0-5cm: Mid grey-brown sandy loam, humic, friable. Frequent fine root systems. Diffuse boundary to:  
5-22cm: Mid grey brown sandy loam. Infrequent fine root systems. Oxidised ironstone gravels <1cm 5%. Clear boundary to:  
22-45cm: Mid yellow brown sandy clay loam. Infrequent fine root systems. Oxidised ironstone gravels <1cm 15%. Diffuse boundary to:  
45cm-base: Orange brown light clay. Oxidised ironstone gravels <1cm 15%

Plates 3, 4 and 5 illustrate typical soil profiles from the intact portions of the site.

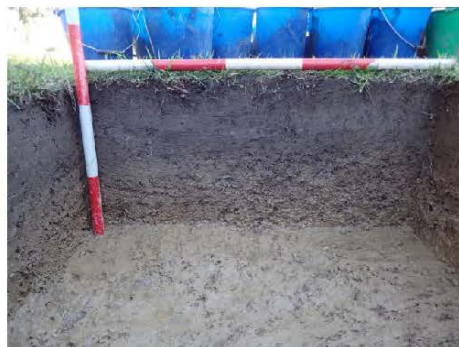
Plate 4. TS16, north-facing section

0-7cm: Dark grey-brown sandy loam, humic, friable. Frequent fine root systems. Diffuse boundary to:  
7-22cm: Mid grey brown sandy loam. Infrequent fine root systems. Oxidised ironstone gravels <1cm 15%. Clear boundary to:  
22-40cm: Light yellow brown sandy clay loam. Infrequent fine root systems. Oxidised ironstone gravels <1cm 15%. Diffuse boundary to:  
40cm-base: Orange brown light clay. Oxidised ironstone gravels <1cm 15%

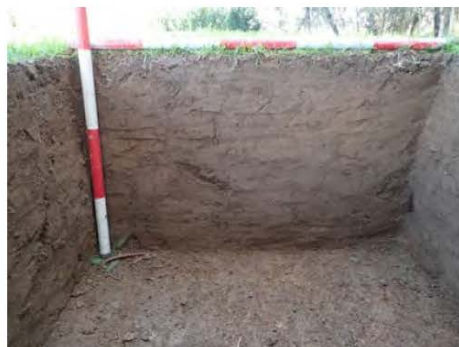
Plate 5. TS15, north-facing section

0-5cm: Mid grey-brown sandy loam, humic, friable. Frequent fine root systems. Diffuse boundary to:  
5-58cm: Light yellow brown sandy loam. Infrequent fine root systems. Charcoal flecking <1cm 5%. Diffuse boundary to:  
58cm-base: Dark yellow brown sandy clay. Oxidised ironstone gravels and charcoal flecking <1cm 5%.

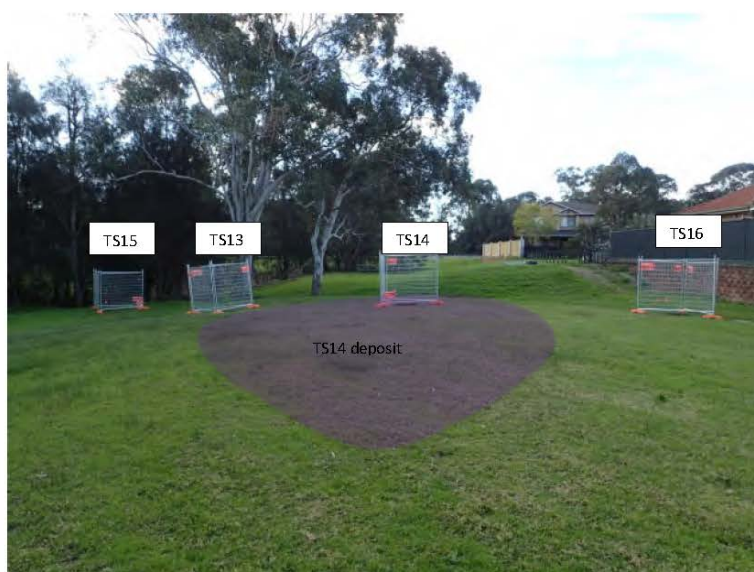
**Plate 6. Location of TS14 deposit**

The highest density square, TS14, was near the northern end of the study area on a terrace landform. Except for two quartz items, all artefacts were made of silcrete. The artefact assemblage from TS14 included 18 cores and knapping debitage of yellow red silcrete. The majority (62%) of the silcrete artefacts from TS14 had no remnant cortex (n=257) while 11 had <30% cortex and 6 had between 31-69% cortex. The TS14 deposit is different than the deposits previously recovered during the salvage program (KNC 2015). Artefact densities are approximately 7x higher within the TS14 deposit and the lithic assemblage was representative of a complete reduction event (characterised by the smaller than average artefact size). The TS14 deposit retains high level of archaeological integrity and information, beyond the results obtained during the salvage excavation program.
